Dendrochronological examination of the Assumption of the Virgin Mary orthodox church in the village of Pades, Greece

The current study is a dendrochronological analysis of the wood from the church of the Assumption of the Virgin Mary, Pades, Greece which was built towards the end of the 18th century according to historical sources. The tree-ring analysis shows that the date, 1784, given on the inscription at the main entrance of the church probably documents the year when the construction works began, and that there were several construction stages of the structural and decorative elements of the church until the early 19th century. Moreover, the oldest (reused) timber elements that were identified through the dendrochronological study date back to the first half of the 15th century and may indicate the first traces of the construction activity in and around Pades. The dendrochronological study enabled the development of three local reference chronologies for the Epirus region. The timespan for the developed chronologies for the church in Pades is: 1262–1825 for *Pinus heldreichii* (Bosnian pine), 1295–1854 for *Pinus nigra* (Black pine), and 1571–1767 for *Quercus* sp. (Deciduous

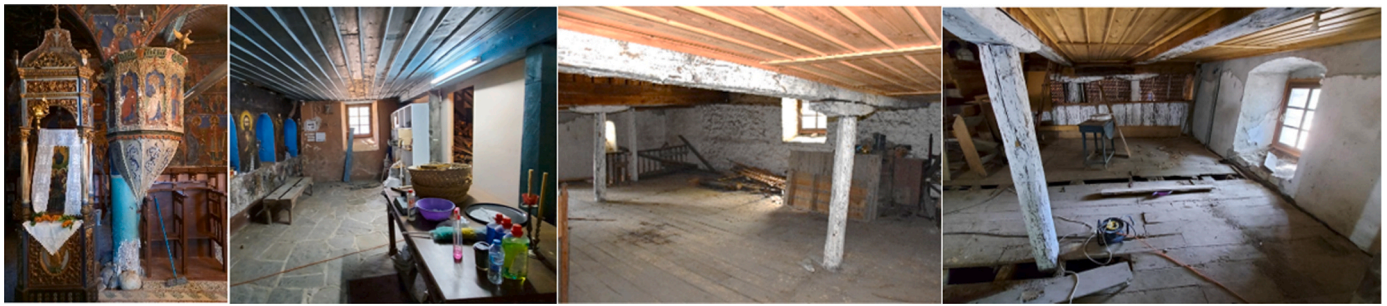
Fig. 4. The timber columns in the nave and on the ground and upper floors of the narthex.

The internal colonnades of the basilica, between the nave and the aisles, are made of wood (Fig. 3 and Fig. 4). These timber columns support the longitudinal horizontal beams through a short piece of timber. The same system is used for the columns in the narthex, supporting the floor, the roof, and the timber parapet between the narthex and the main church (Fig. 4).

Six (6) samples from the beams (joists) and two (2) samples from two planks belonging to the floor of the narthex (Figs. 4, 5 and Fig. 11 and Fig. 12) were collected. All these samples were identified as Black pine. Three (3) samples had preserved bark edge. The two planks of the flooring (Samples 30 and 31) were also dated. Plank 30 had a bark edge, and its date shows that it belongs to the original flooring, while Sample 31 was probably used during a later intervention (after 1859). The floor planks are usually one of the most frequently restored parts of the

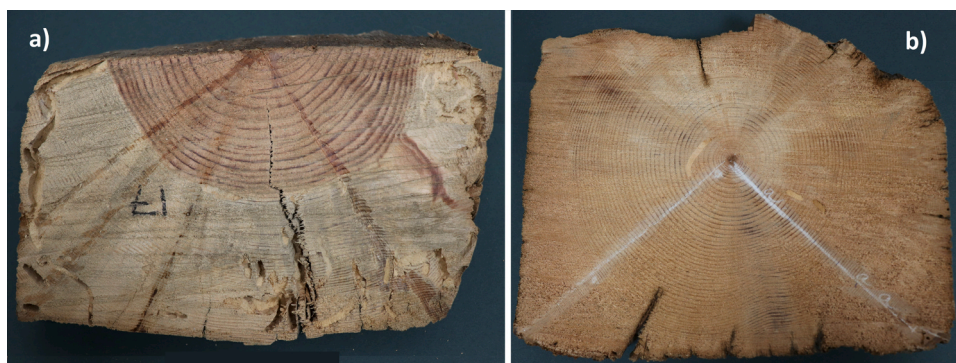
Fig. 6. a) Black pine (*Pinus nigra*) sample with visible brighter and wider sapwood area; b) Bosnian pine (*Pinus heldreichii*) sample with narrow and not-easily-distinguishable sapwood area.

Besides microscopic identification, the macroscopic analysis of the samples also clearly shows the difference between the two pine species. In Black pine the sapwood area is much wider and easily visible with the naked eye. Sapwood in Black pine may also have a slightly gray blue color (Fig. 6a) resulting from fungal activity causing wood discoloration. In Bosnian pine the sapwood area is much narrower (Fig. 6b).

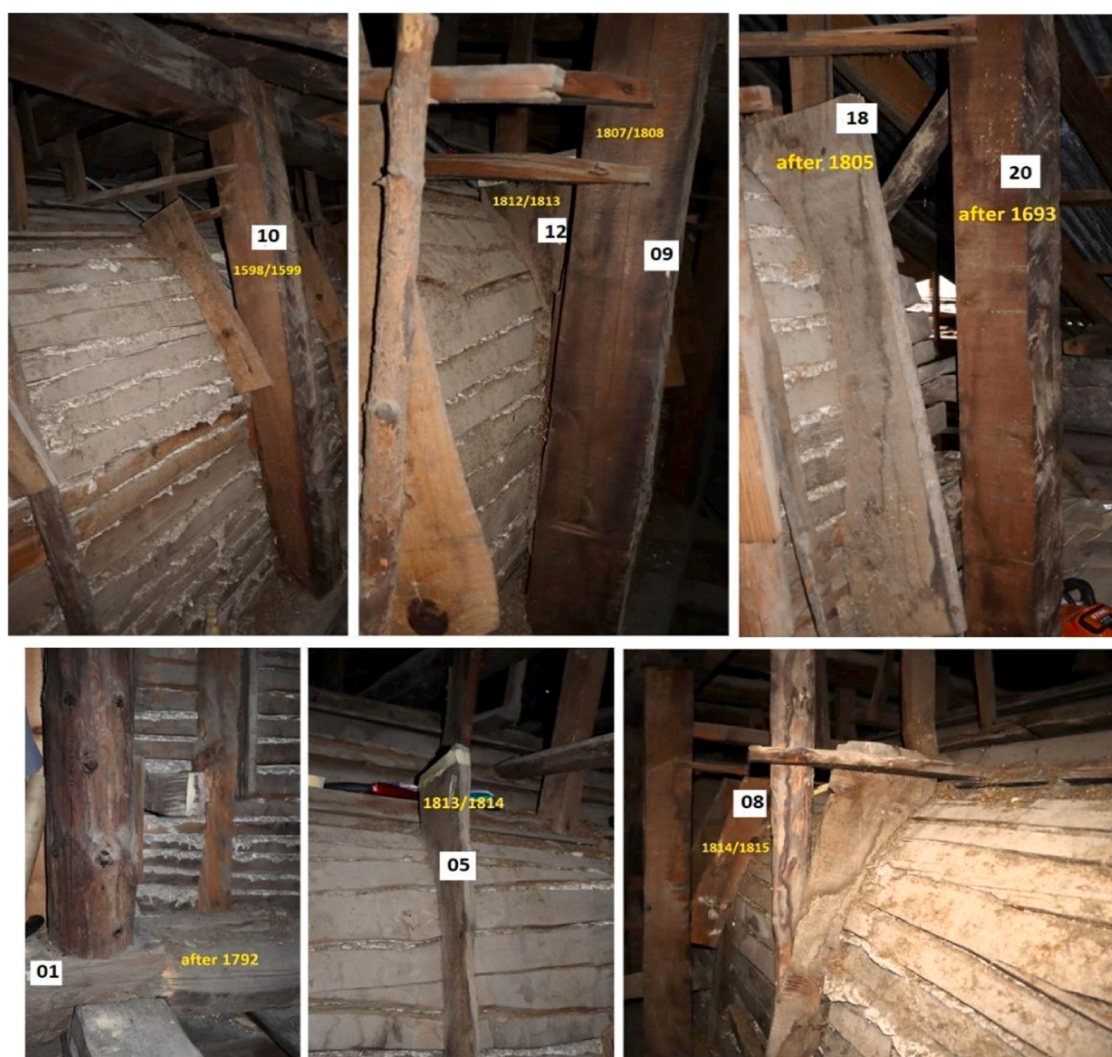
Fig. 8. Dated roof posts and curved elements of the load-bearing timbers of the vaulted central ceiling.

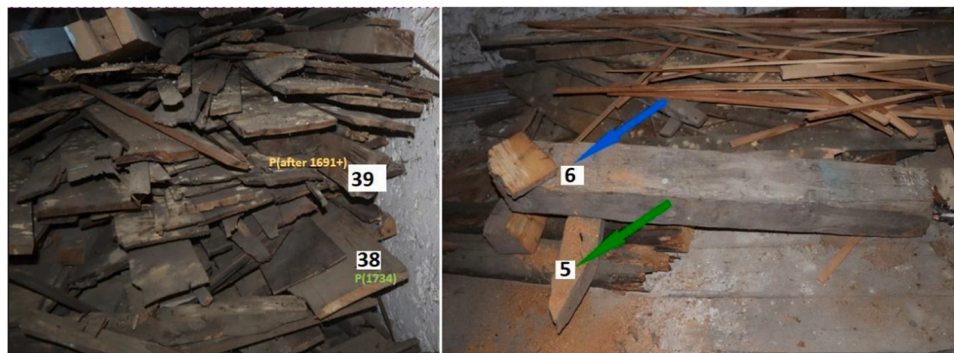
Fig. 10. Timbers found in a pile stored on the floor of the narthex.

Six (6) samples were collected from a pile of timbers stored on the upper floor of the narthex (Figs. 10, 11). These timbers showed traces of former use and may have been stored there for reuse and recycling during potential future restoration works. Two of them (Samples 38 and 39) provided older dates (after 1691 and 1734 respectively).

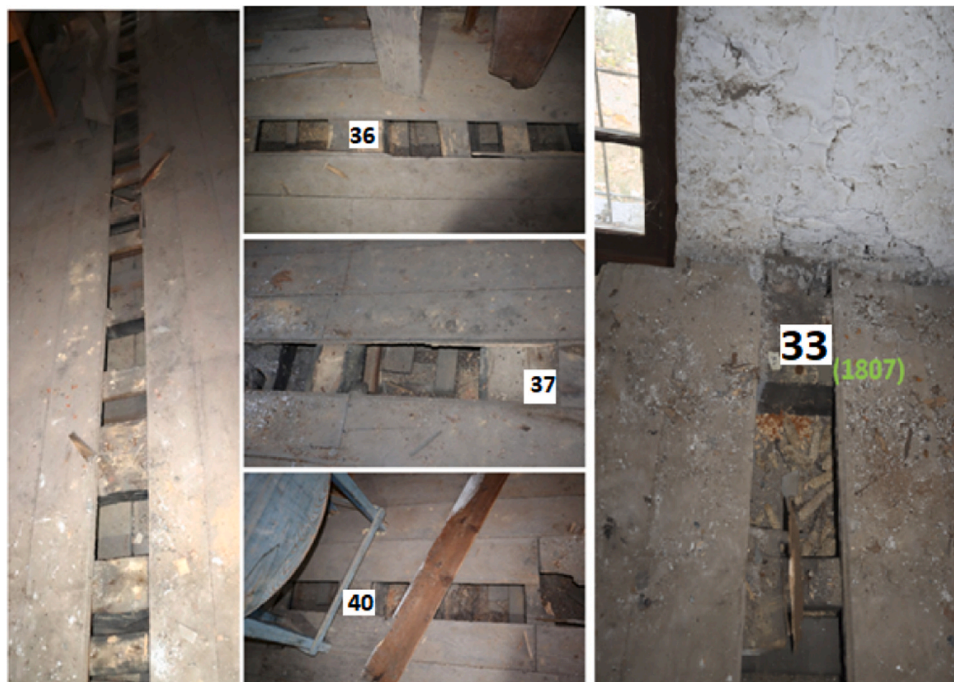
Fig. 11. Revealed beams from the floor of the narthex (Samples 33, 36–37, 40).

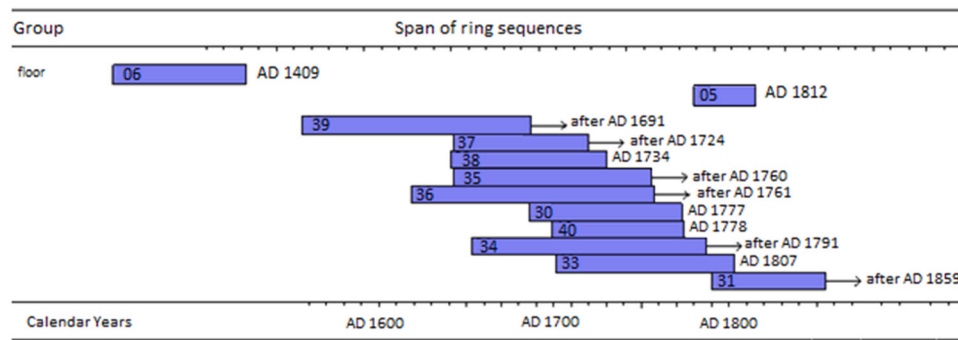
Fig. 12. The chronological span of the dated timbers from the floor of the narthex and the stored timber pile. The graph was prepared in DENDRO for Windows (Tyers, 2004).

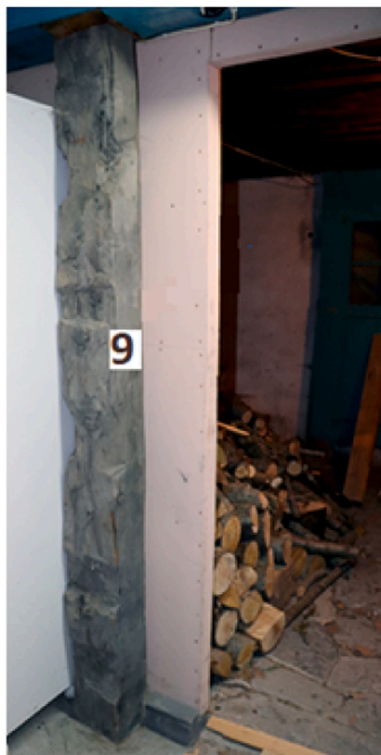
Fig. 13. Reused column – Sample 9.

Among the oldest timbers (Sample 9) with visible traces of surface leveling with an axe, another example is an element from the ground level of the narthex that was reused as a column for the main intermediate longitudinal beam of the floor on which the beams (joists) of the floor rest (Fig. 13). Cutting year of the intermediate beams supporting the floor beams can be tentatively placed in the second half of the 18th century at the earliest due to their heavily damaged outer parts destroyed by insects and the numerous missing outer rings (Fig. 14).

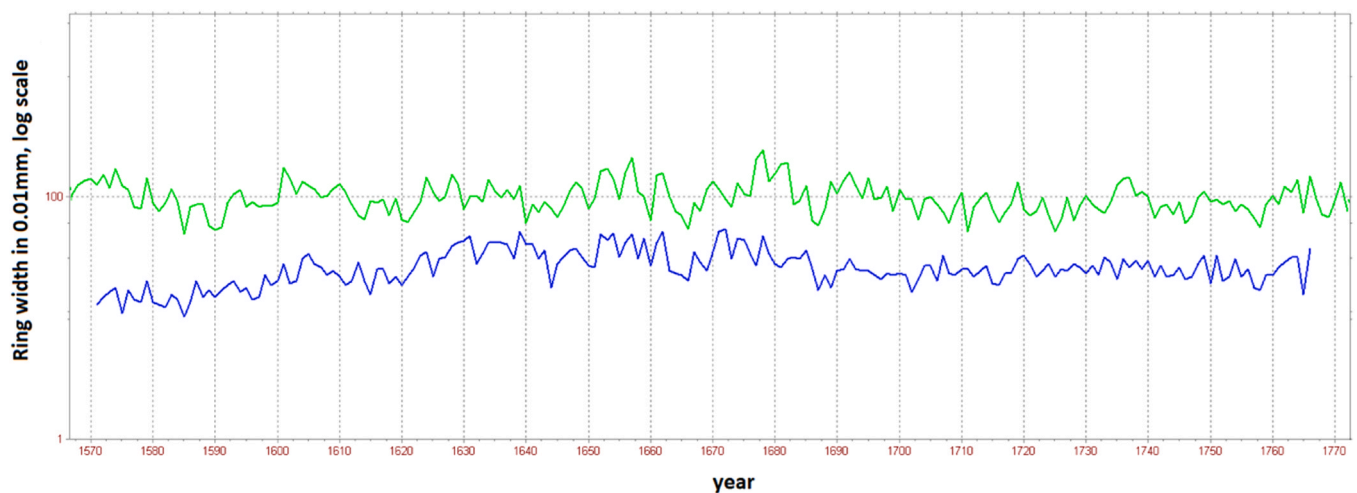
Fig. 18. Visual cross-matching of the developed mean *Quercus* sp. chronology (PadesQu2 in blue) and the reference SW Balkans oak chronology (Yugo1619 in green) providing the best cross-dating results. Only the overlapping period of the reference chronology is presented here.

there is no sufficient information or data providing the precise location concerning the oak timber origin (Fig. 18).
