# VENETIAN AND OTTOMAN HERITAGE IN THE AEGEAN

THE BAILO HOUSE IN CHALCIS, GREECE

DENDROCHRONOLOGICAL DATING OF THE BAILO HOUSE WITH A  
SUPPLEMENTARY COMMENT ON THE CHURCH OF AYIA PARASKEVI

TOMASZ WAŻNY, PETER KUNIHOLM, AND CHARLOTTE PEARSON

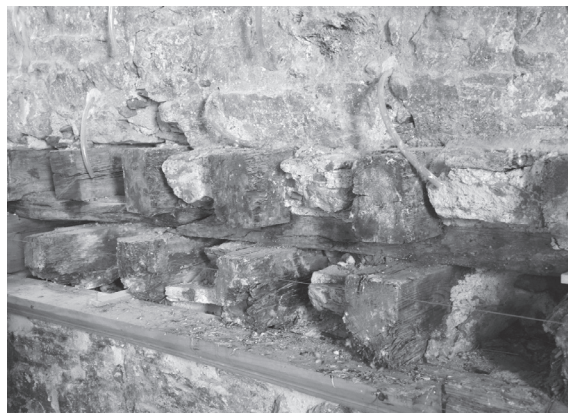
Fig. 1. Venetian part of the Bailo House. Southern wall with ends of the first floor beams exposed. Dating results: AD 1327–28.

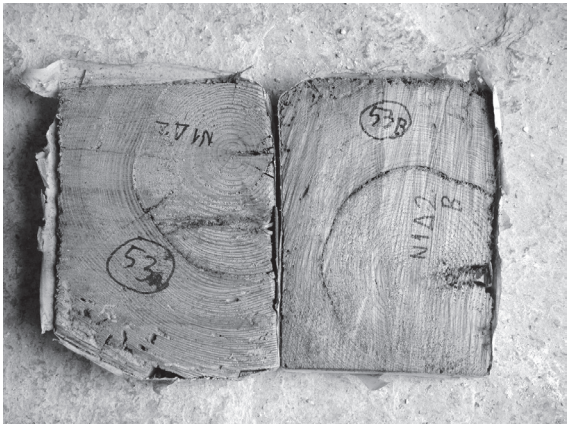
Fig. 3. Samples taken from both ends of beam no. 53, south wall, first floor (before sanding). The last preserved ring grew in AD 1327.

Wood samples were taken in the form of saw-cut slices (**Fig. 2**) and drilled cores. The surfaces of the samples were prepared in the laboratory to expose the tree-ring boundaries. Next, the samples were measured using a LINTAB platform under a reflected-light microscope. Tree-ring widths were the measured parameter and had a 0.01 mm precision of measurement. The tree-ring series were registered on a TSAPWin system. Cross-sections of the oak support system (headers and stretchers) inside the masonry that could not be moved were cleaned with sandpaper and measured *in situ* (**Fig. 3**).

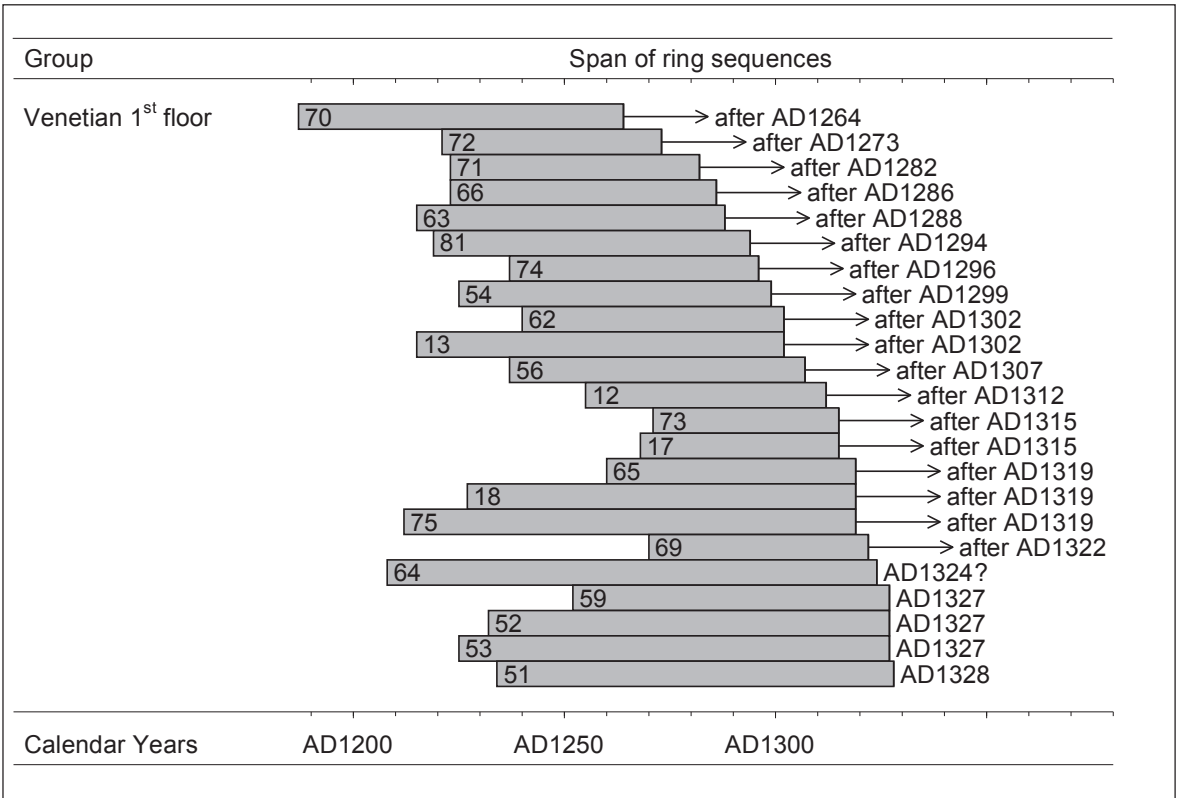
Fig. 4. Venetian first floor (fir) — dating results.

The first floor was built according to a construction technique that was employed in Venice from 1300–1425.<sup>4</sup> Similarities with the Palazzo Ducale floor would likely place it after 1340. The dendrochronological dating results place the construction of the first floor at the beginning of the expected period — in the years 1327–28 (**Fig. 4**). All timbers are of local fir; therefore, long-distance transportation from forest to construction site could be excluded.

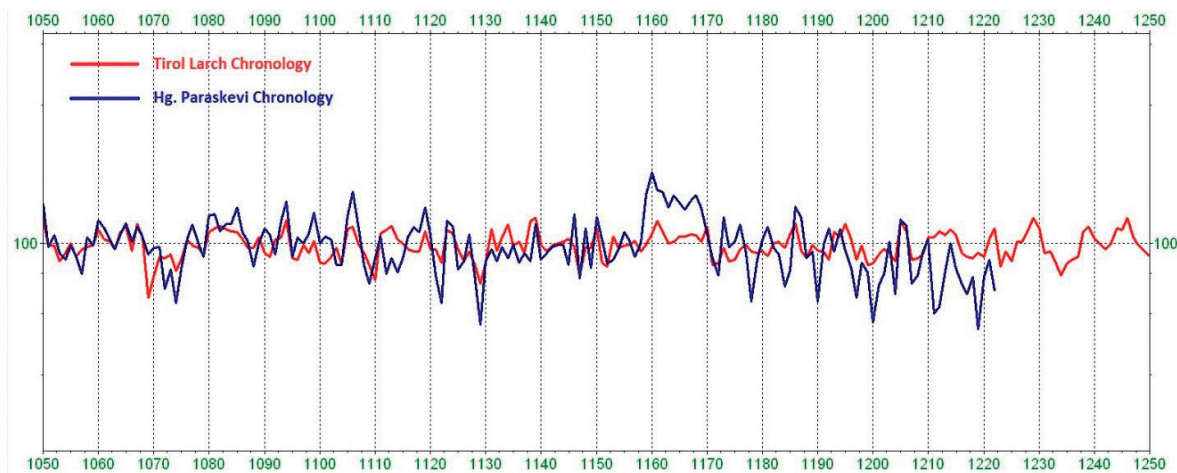
Fig. 10. Comparison of the PSKLARCH sequence with the Innsbruck Alpine larch chronology. The statistics confirm the visual correlation between the two tree-ring series: first, the overlap of 213 years is good; then the TH-value of 11.2 (calculated according to Hollstein 1980), where scores above 4.0 are significant; GL represents the percentage of year-to-year changes in ring widths that are the same, both simultaneously increasing or decreasing (45 per cent–55 per cent would be a random fit) between the ring-width sequences of the two chronologies (Eckstein and Bauch 1969); CDI, the Cross Dating Index which is the sum of the two, is 72. A CDI of 40 is good. A CDI of 72 is excellent.

PSKLARCH, a 213-year sequence from 1010–1222. The quality of the fit with the Innsbruck larch sequence is presented above (**Fig. 10**). A missing two or three or four centimeters of wood, lost during the process of squaring the timbers, would add some 40/60/80 years to the end dates reported here, thus fitting in neatly with the time (1261) when the Latin Patriarchate was translated from Constantinople to Negroponte.<sup>8</sup> A missing four centimeters of wood would place the cutting date for Ayia Paraskevi at about the same time as the building of the Bailo House at 1328. Which building was built first is for the historians to tell us.

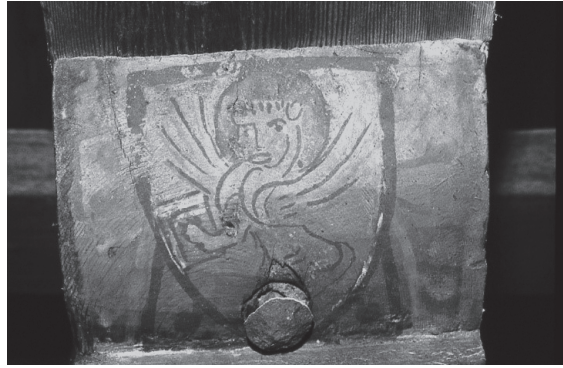
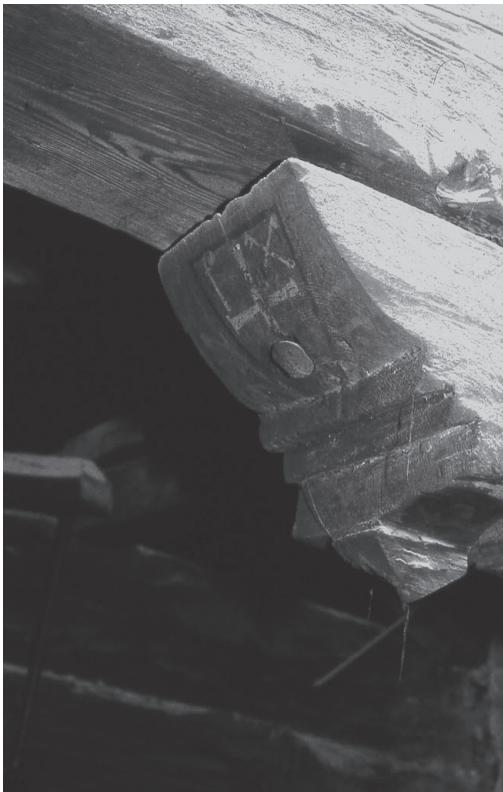
Fig. 11. (a) Access to the truss brackets. (b) The winged lion of St Mark holding the Bible on PSK-8. (c) The shield and cross, decorated with a bishop's crozier on the upper left and the crossed keys of St Peter on the upper right on PSK-9.

**PSK-8** North wall of naos, roof truss bracket, fifth from west, decorated with five tetrahedral saw teeth on each side, a standing row of red hooks, and on the end a painted shield with a rampant winged lion of St Mark holding the Bible (originally invisible from floor level until dusted off prior to the drilling). One hundred eighty-seven rings from 1026 p.-1212+?

**PSK-9** North wall of naos, roof truss bracket, fourth from west, decorated with five tetrahedral saw teeth, painted triangles along the edges, painted decorations along the sides that could not be deciphered in the available light, and on the end a painted shield, large white cross, a bishop's or archbishop's crozier in the upper left quadrant, and crossed keys (representing the metaphorical keys of the office of St Peter) in the upper right quadrant (also invisible from floor level until dusted off). Two hundred thirteen rings from 1010–1222+? (**Fig. 11c**).

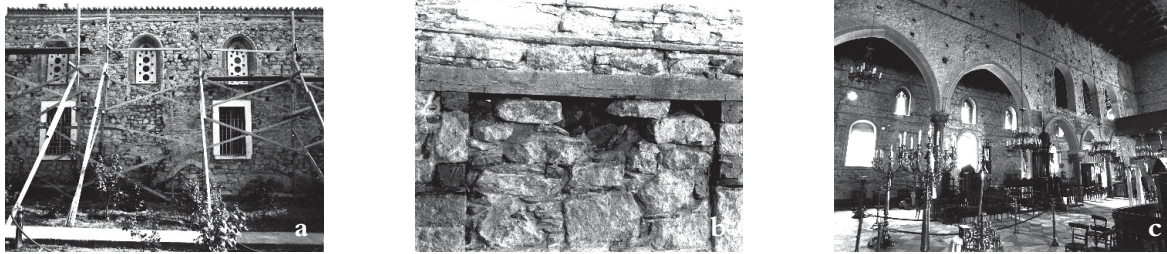
Fig. 12. (a) The north flank wall after the conservators had stripped off the plaster. The suppressed window is in the middle. (b) A typical Turkish-style lintel and transverse beams. (c) The south flank wall from the interior with the blocked window behind the candelabra. Before the nineteenth-century earthquakes the nave arcade, where now the rectangular windows are above the west gallery, would have continued on one more intercolumniation to the columns which abut the west wall on the exterior and then most likely one more interval beyond.

The earliest intervention seems to be in the naos, north flank wall, part of the filling below a disturbed western lancet window between the buttresses (see plan, **Fig. 12a**), drilled from the interior where it might still be visible. The last preserved ring is from 1467. With an allowance for some more years of sapwood, the cutting date should be in the late 1470s or early 1480s. Remember that the Ottoman conquest dates from 1470, only a decade or so earlier.

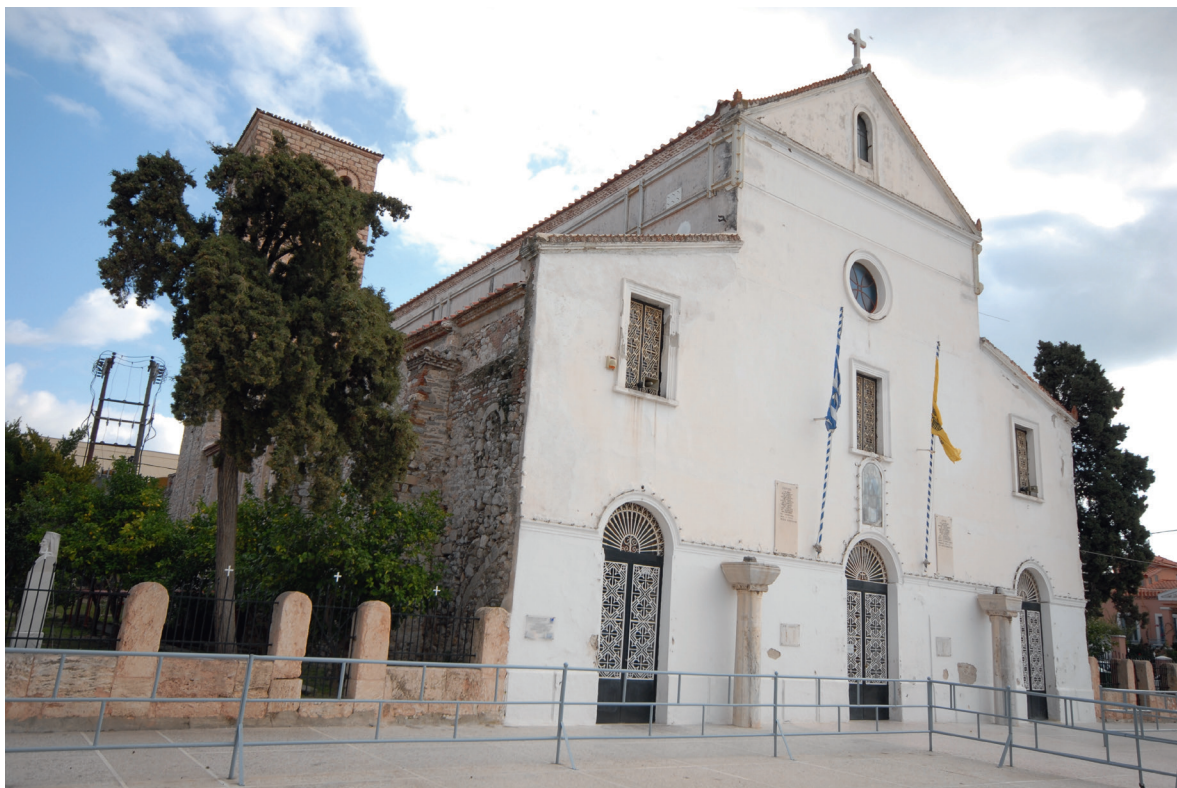
Fig. 13. (a) The plan by Liapis showing how the exterior columns are at the exact proper distance from the westernmost column on the interior so that the arches seen in fig. 10c above would have continued beyond the present western wall of the church. (b) The west façade of the church from the nineteenth-century rebuilding. The Venetian building would have extended one more intercolumniation or some fifteen meters further out into the *plateia*.

During or after the nineteenth-century earthquake(s), the west façade of Ayia Paraskevi fell down and was rebuilt. We collected some small but very short-lived, and therefore undatable, samples. The longest one, PSK-5, had only fifty-nine rings. The original west wall of Ayia Paraskevi stood about 15 m west of where it is now. The nineteenth-century rebuilders of the church truncated it, leaving the westernmost columns standing in place as apparent decorative elements (**Figs 13a–b**).
